Date: June – 2014

Document Number: 95-142659-A

## **EXPLORER 710 Battery contact issue**

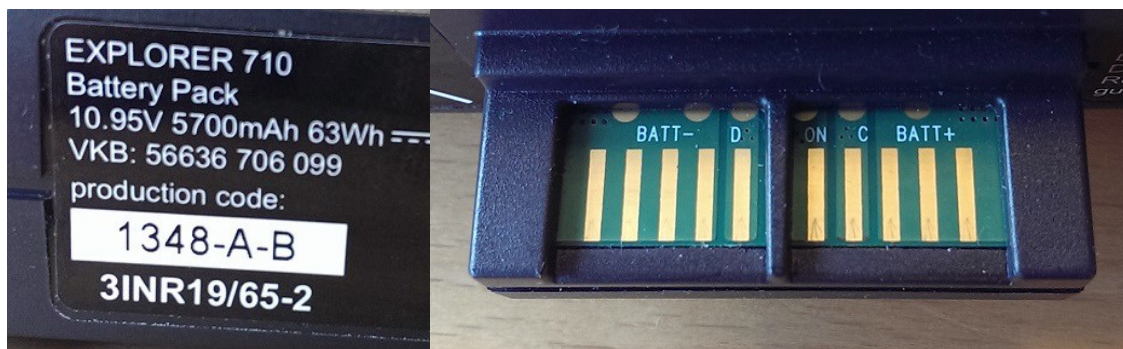
Batteries which may be affected will have production code **older** than **1419** (2014, week 19) **and not** reworked as illustrated in picture "Reworked from factory" on next page.

The below is an example of label from a battery which may be affected.

Note! - Replacement of battery can only take place when both production code is older than 1419 **and** contacts/PCB is not reworked.

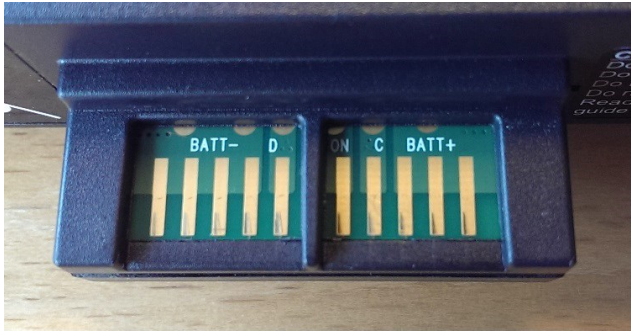
Production code 1419 and newer

The below pictures illustrates the two methods used for improved/new contact surface where the solder mask has been changed.
