Fleet77/55 Trouble Shooting Guide

Issue 1.00

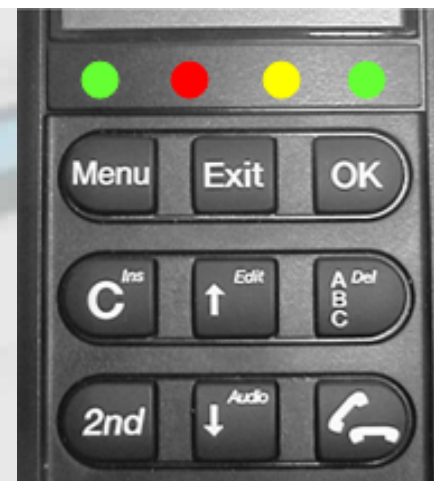
Handset LED definition

Has a dual function. Initially, the LED will illuminate steadily when the system is in synchronization with a satellite.

When the system has established a data-call, this LED assumes its secondary function as a data transfer light. When data is being transferred (sent or received) the LED will flash. This is a quick visual reference during data communications.

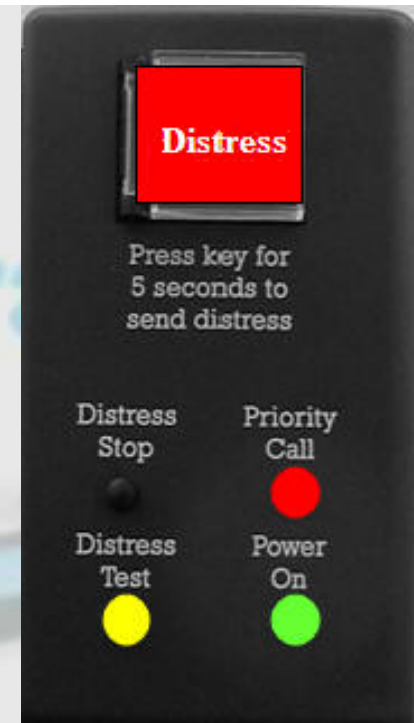
Handset Cradle LED definition (only available on the Fleet77)

Power On (green):

When On, it is indicating that the Fleet77 system is powered.

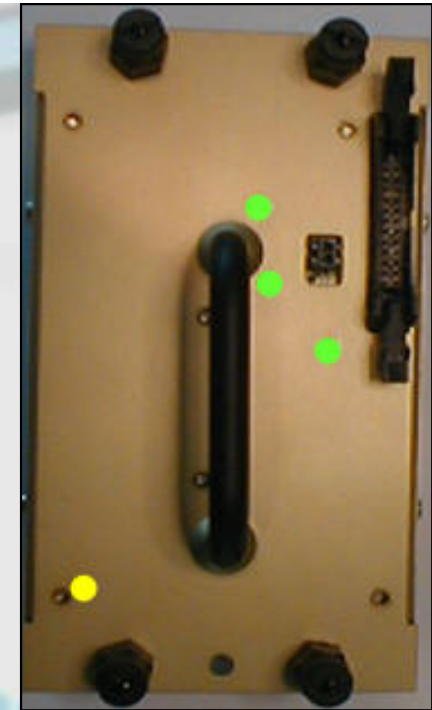
Power Supply Module LED definition

PSM On (yellow):

Is lit to indicate that the +40 VDC from the BDU via the HPA is provided to the PSM.

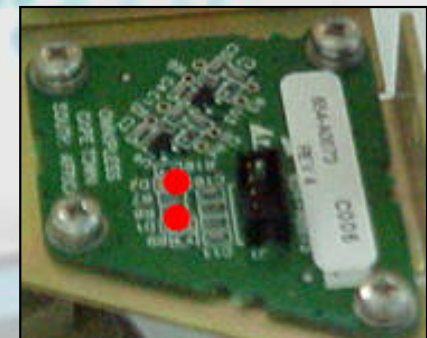
Azimuth Zero Sensor Assembly LED definition

Normally On, but as the beam of the Opto-encoder is broken, the LED is going Off.

D1 (red):

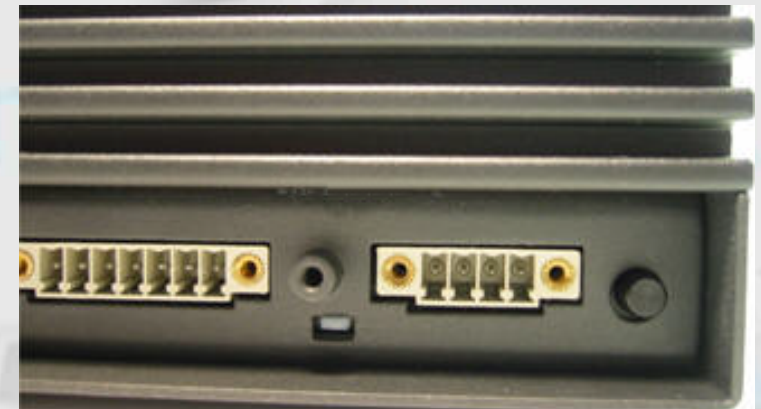
If the software of the BDU locks up, often seen by the error message "**Handset Com Error**" in the Handset, also the BDU needs to be reset. But in this case the On/Off switch can not provide the reset function, as the software is not recognizing the signal from the switch. In this case the only reset possible is the "hardware" reset (switching off the mains switch for the Fleet77/55 or if no mains switch available, disconnecting the power connector on the rear side of the BDU). Please remember to unscrew the safety screws on the connector.

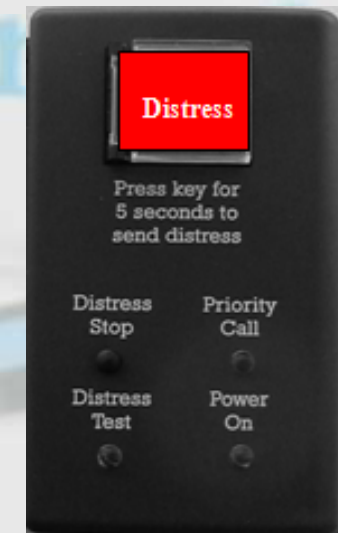
- f. While the distress test is enabled, press the Distress button on the cradle for 5 seconds or until the light on the button stops flashing and the buzzer stops beeping.
- g. After 15 seconds all ongoing calls will be pre-empted.
- h. A list of distress LES's is presented in the handset display. Use up or down and OK to select a LES. If a LES is not selected within 15 seconds, the pre-configured LES will be selected instead.

- i. The handset display will now go from "**Distress calling**" to "**Distress connected**" as the call progresses.
 - 1. "**Distress connected**" also means that the test was a success.
- j. To abort the test call press Offhook/Onhook or wait 120 seconds, after which the call will automatically be disconnected.

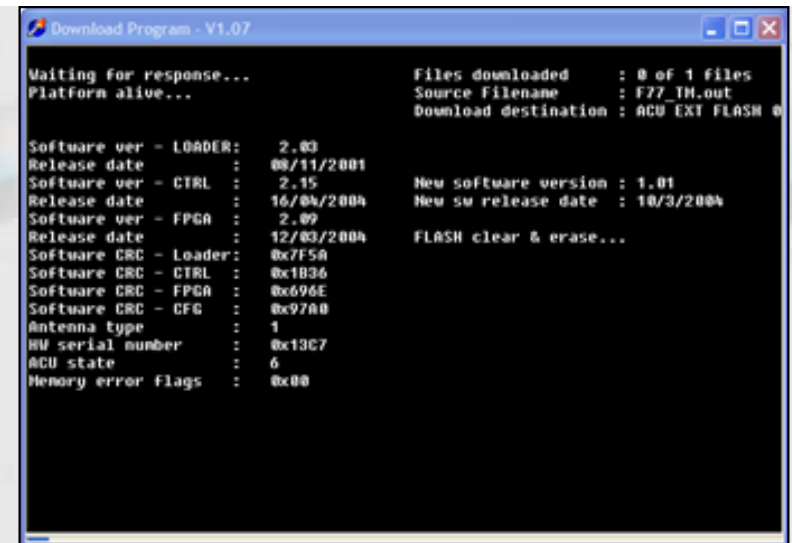
8. A window "Download Program V1.07" is opened, and an "ACU to RX2" upload program is loaded into the ACU, so that the RX2 SW can be transferred from BDU via ACU to the RX2.

8. When the message "**Download complete**" is shown, close the window.

Download Program - V1.07
Waiting for response...
Platform alive...
Files downloaded : 0 of 1 files
Source Filename : F77_TM.out
Download destination : ACU EXT FLASH 0

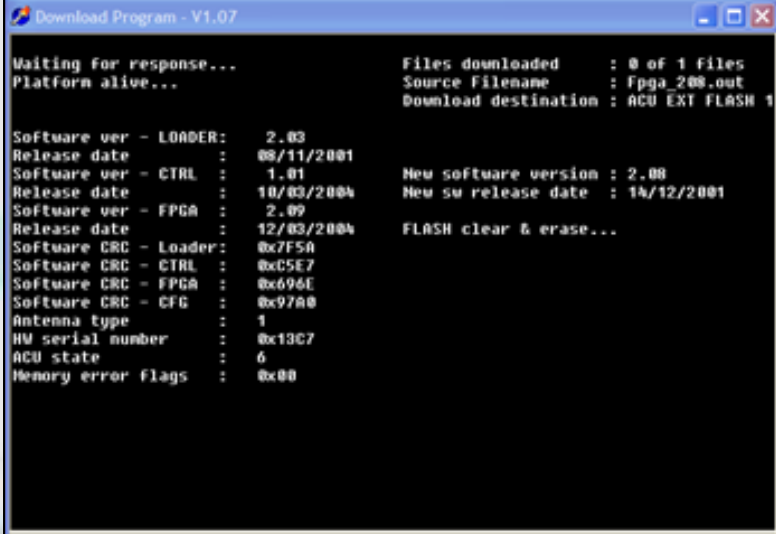
16. Again the window "Download Program V1.07" is opened, and a new loader program is uploaded to the ACU, so that the actual ACU SW can be uploaded.

Download Program - V1.07
Waiting for response...
Platform alive...
